Inspection Report

Joe Smith Report

Property Address:
111 Main Street
St Augustine FL 32080

Eagle Eye Home Inspections

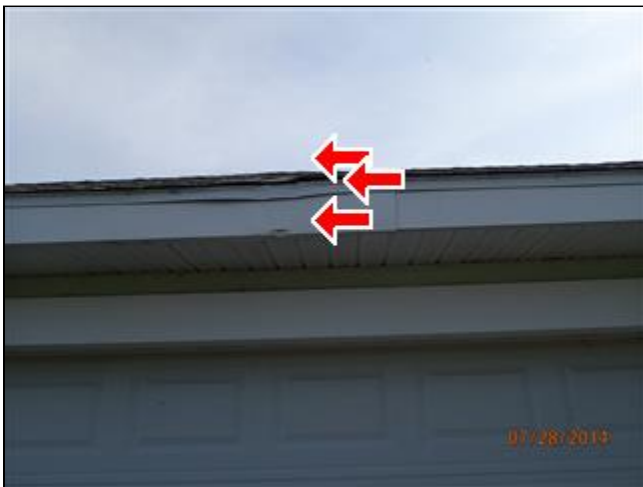
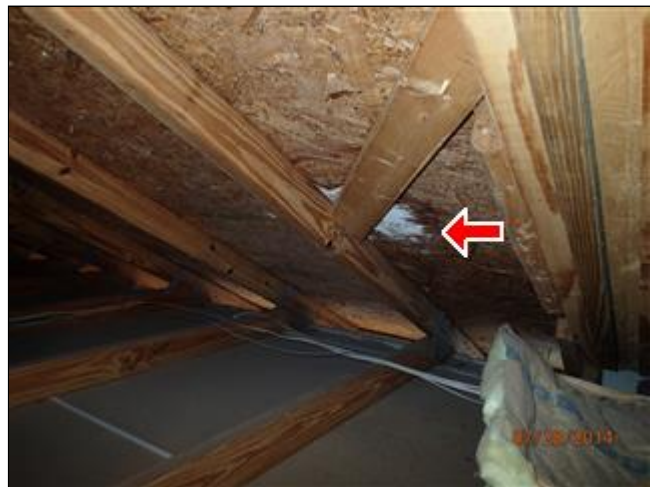
1.0 There is damage to the shingles, drip edge and fascia covering above the garage, repairs needed.

There is an active roof leak visible in the attic on the roof decking above the garage, repair needed.

The roof appears to be the original from 2002, average life of a shingle roof is 20 years.

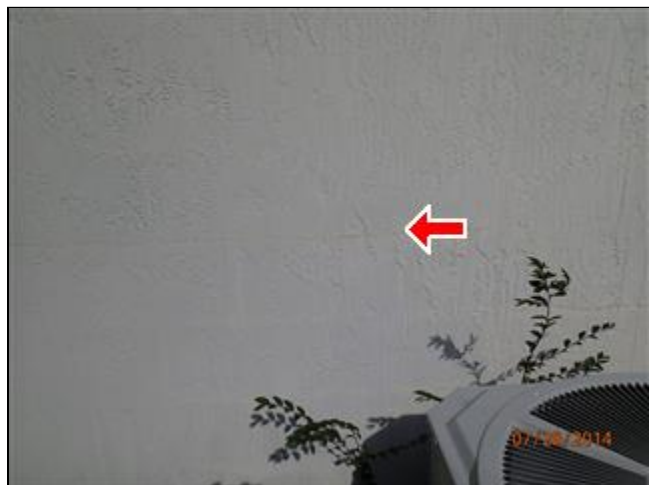
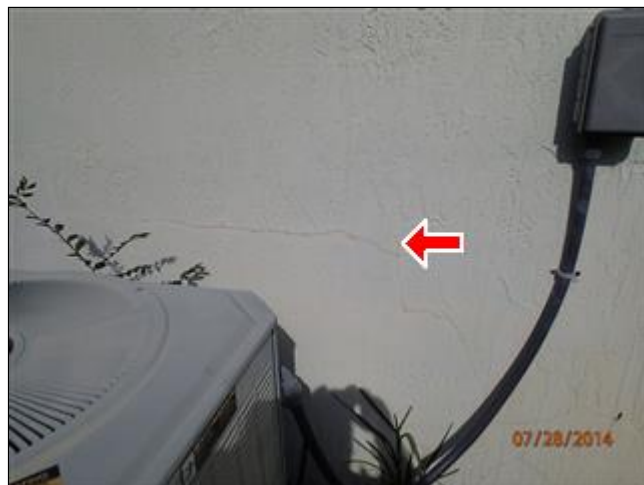
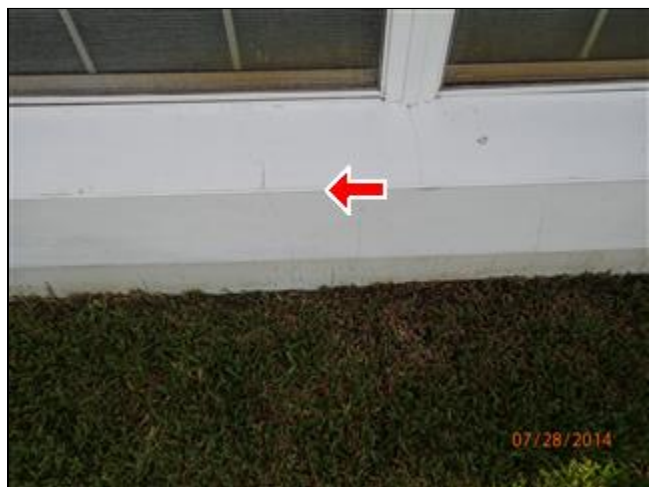
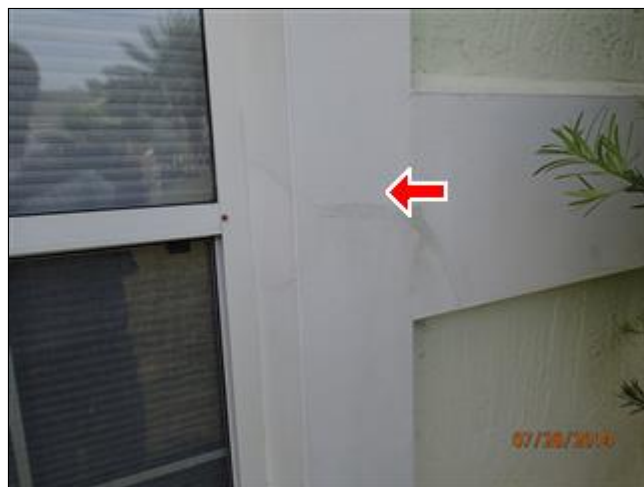
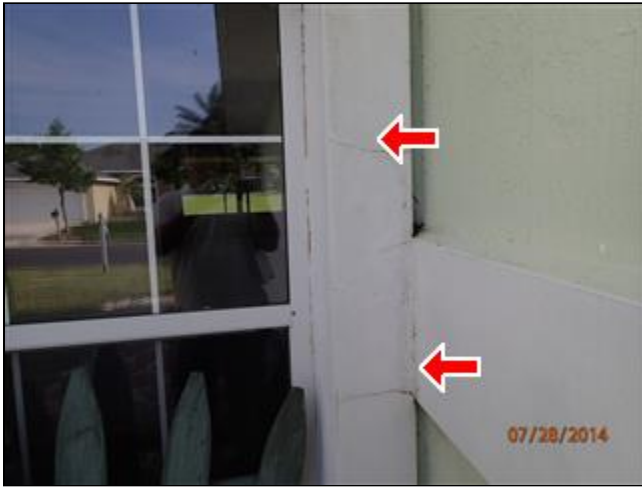
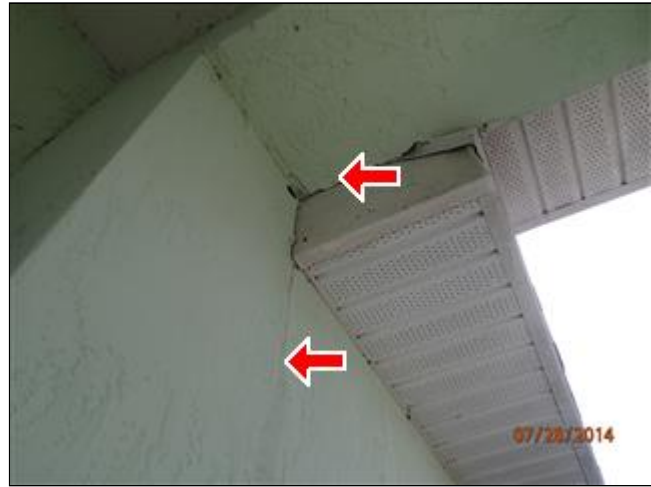
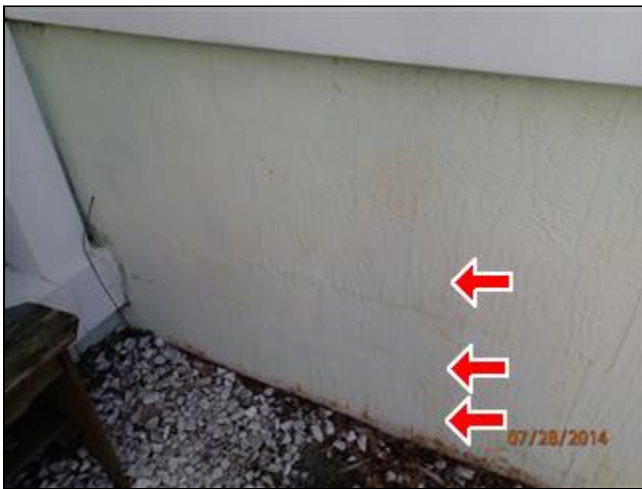
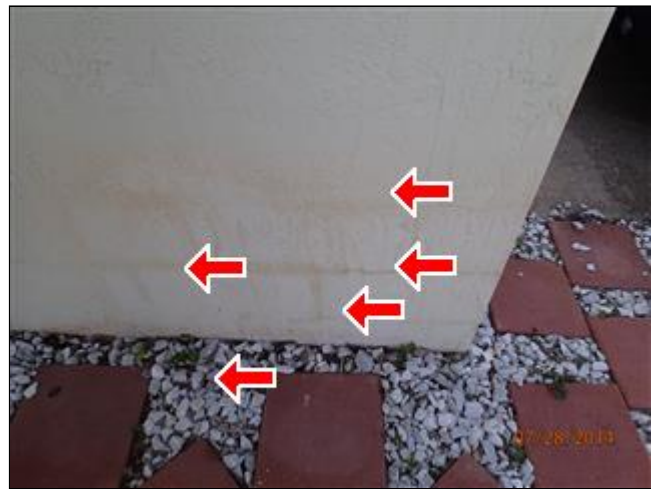
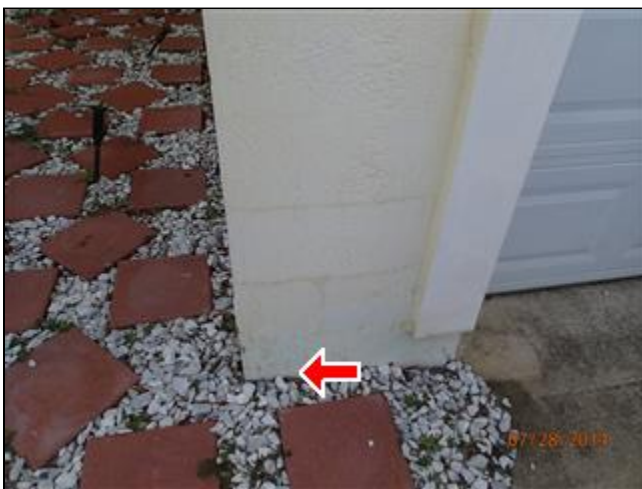
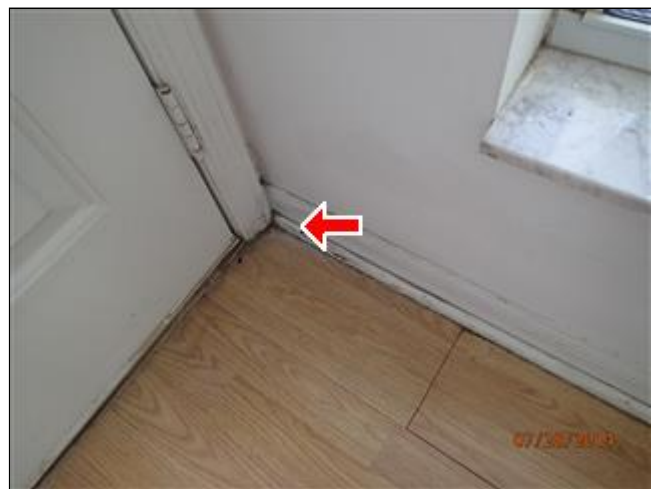
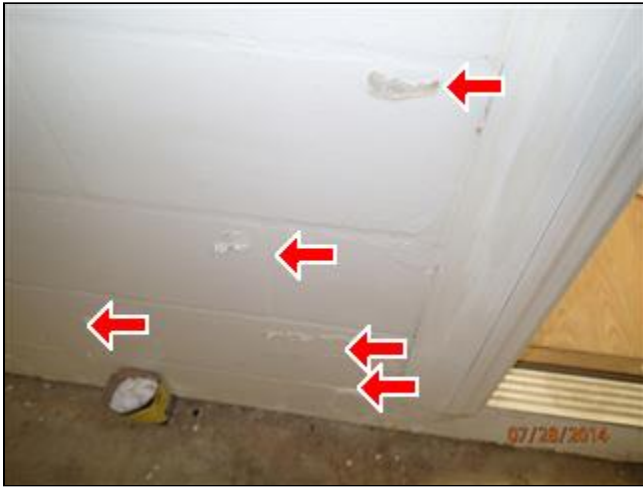
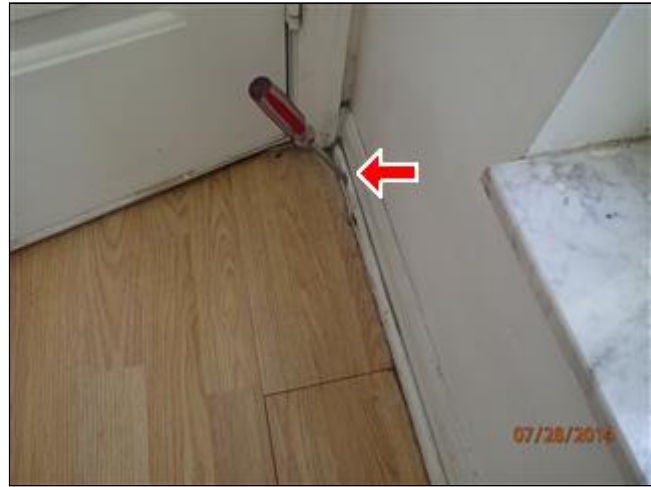
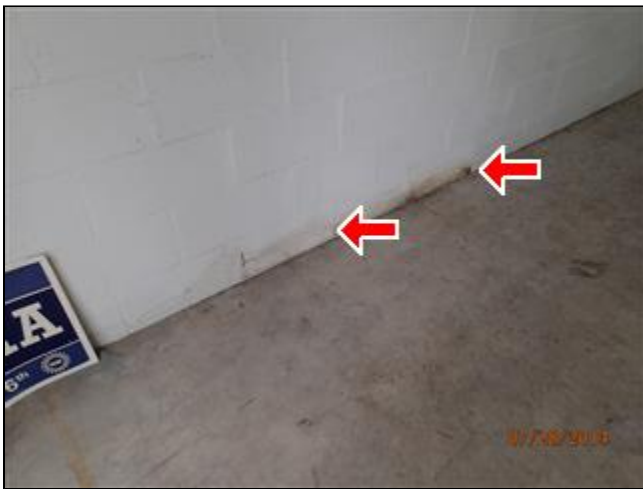
**2.0** Recommend repairing all exterior stucco cracks, caulking around doors and windows, painting house as needed.

There is evidence of water intrusion into the block walls of the laundry room and the garage, there is moisture damage to the base boards in the laundry room and several stains in the garage block wall. Recommend corrections and repairs. The ground level along the garage appears to be too high and there are several cracks in the exterior stucco, repair all cracks and paint the house to prevent further water intrusion.

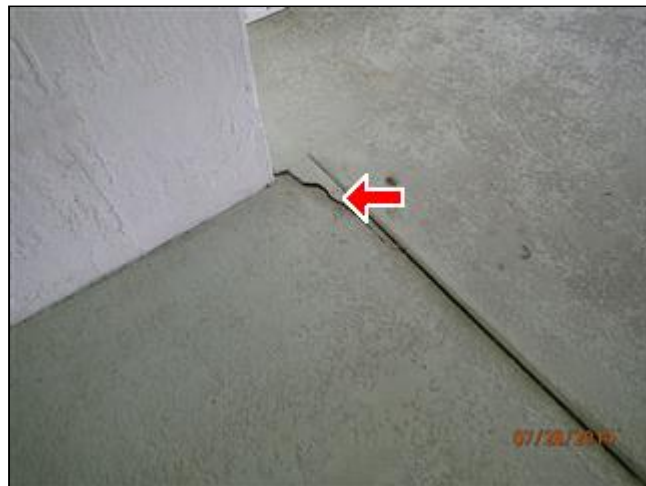
2.3 Picture 1

**2.3** There is a wide crack on the floor of the patio. The edge of the crack is raised and sharp, it can cause injury, repair for safety.

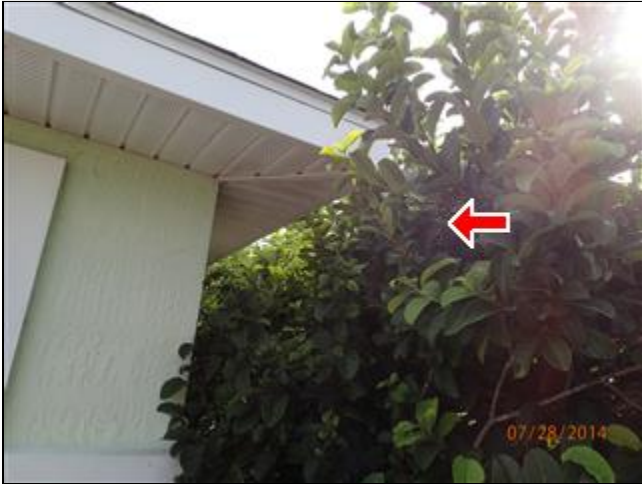
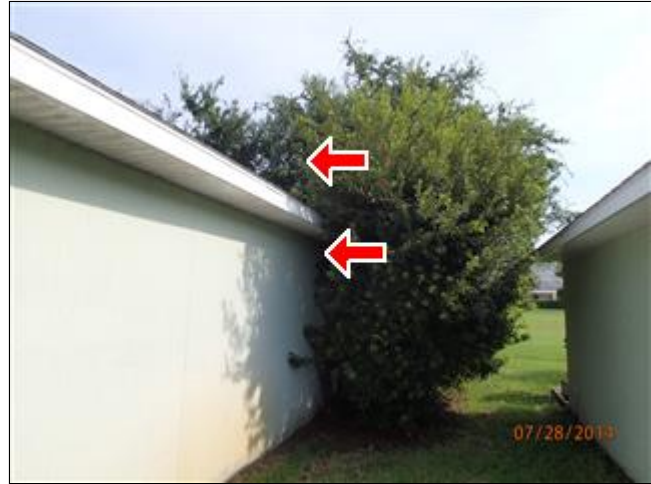
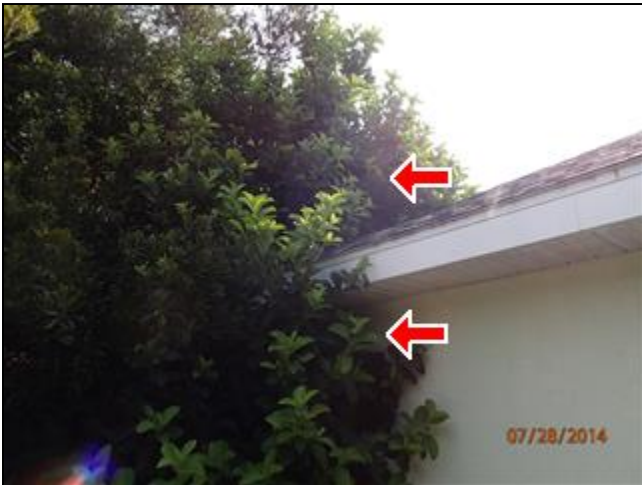
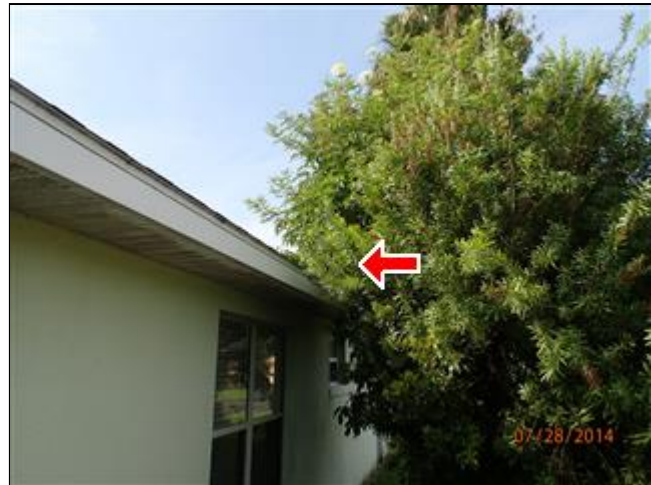
**2.4** The tree limbs that are in contact with roof or hanging near roof should be trimmed.

The landscaping was over grown and in contact with the exterior walls, trim all landscaping at least one foot away from the walls.

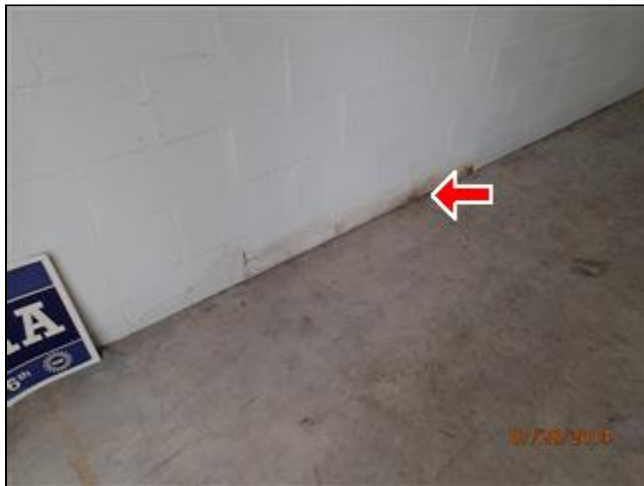
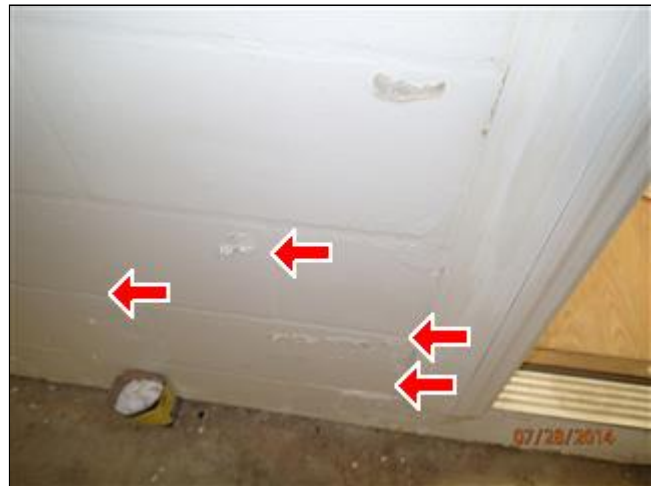
3.1 There is evidence of water intrusion into the block walls of the laundry room and the garage, there is moisture damage to the base boards in the laundry room and several stains in the garage block wall. Recommend corrections and repairs. The ground level along the garage appears to be too high and there are several cracks in the exterior stucco, repair all cracks and paint the house to prevent further water intrusion.

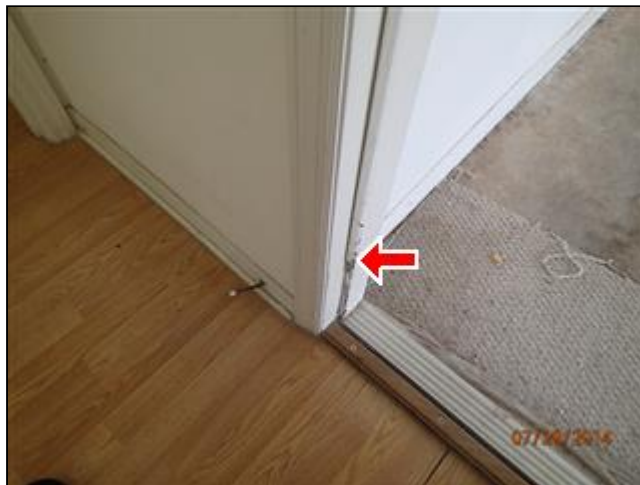
3.4 Picture 1

**3.4** The weather stripping was damaged at the garage to house door, replace damaged stripping.

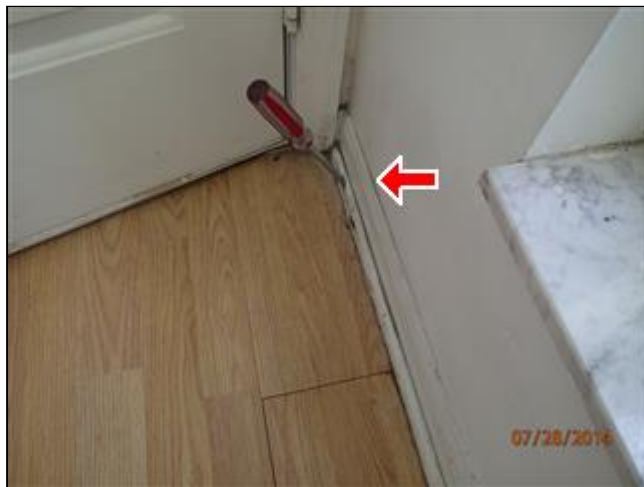
4.1 Picture 1

**4.1** There is evidence of water intrusion into the block walls of the laundry room and the garage, there is moisture damage to the base boards in the laundry room and several stains in the garage block wall. Recommend corrections and repairs. The ground level along the garage appears to be too high and there are several cracks in the exterior stucco, repair all cracks and paint the house to prevent further water intrusion.

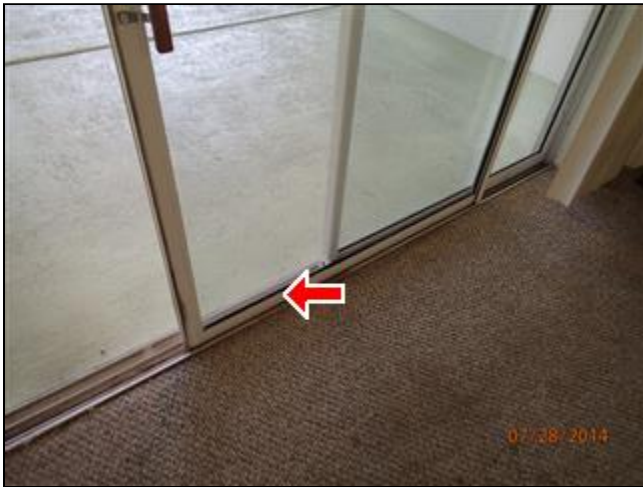
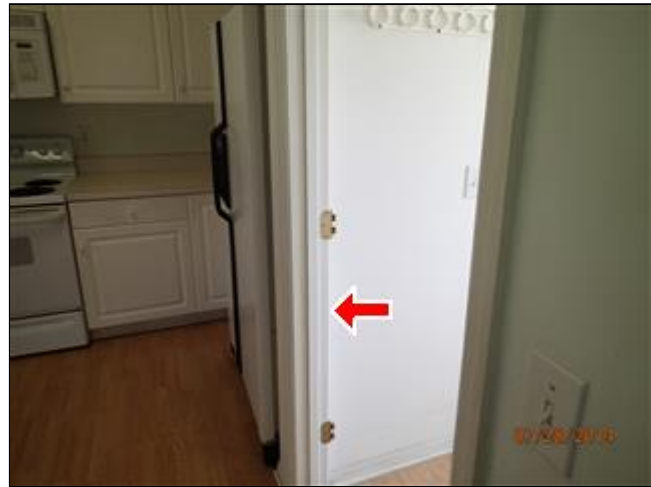
**4.5** The sliding glass door did not roll smoothly, repair needed.

The door for the laundry room was missing.

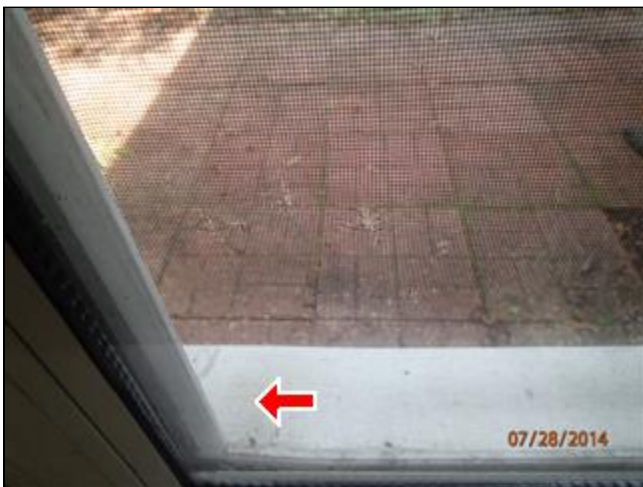
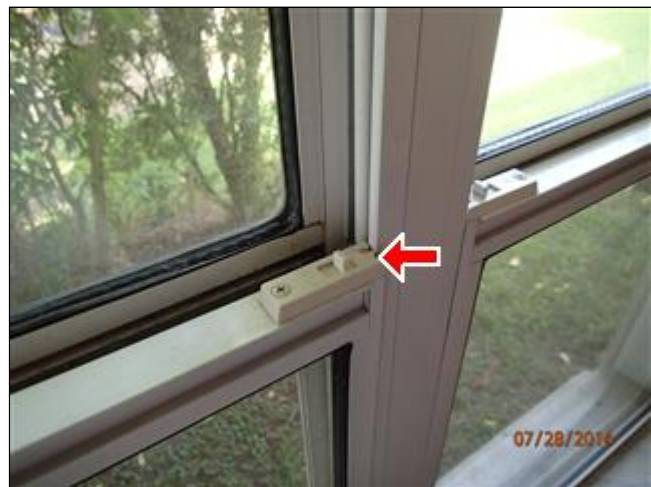
**4.6** A few of the window screens were damaged, replace the damaged screens.

The window in the study has a window tilt latch that is not operating properly, it pops out when operating the window, repair or replace this latch.

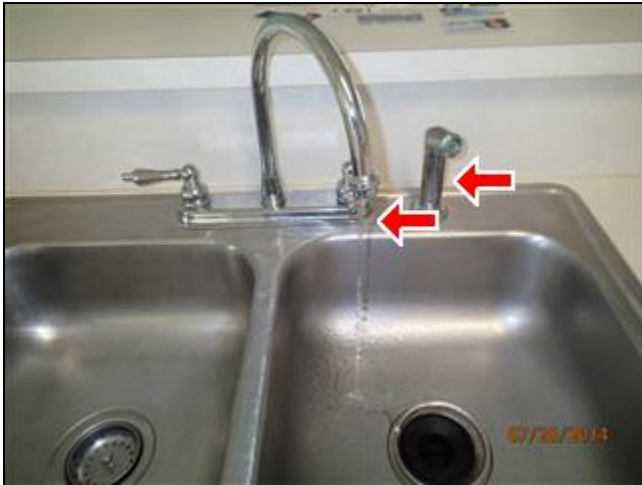
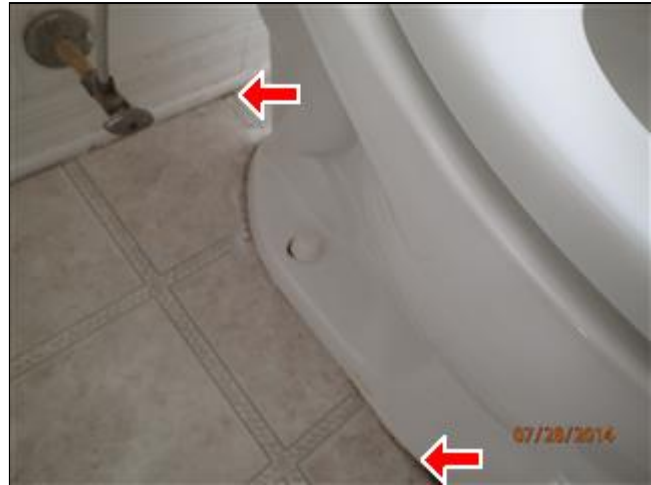
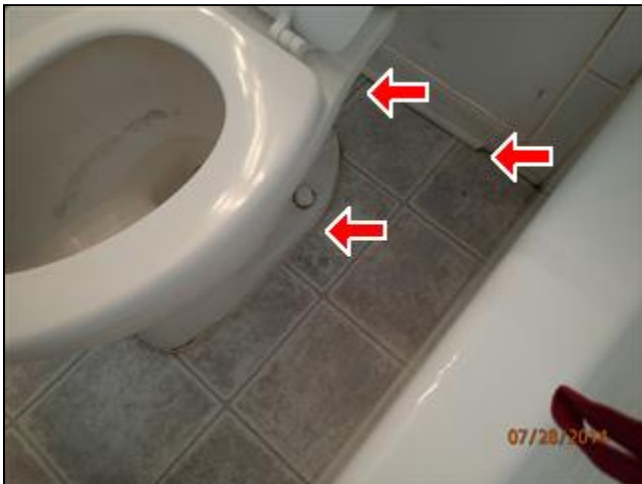
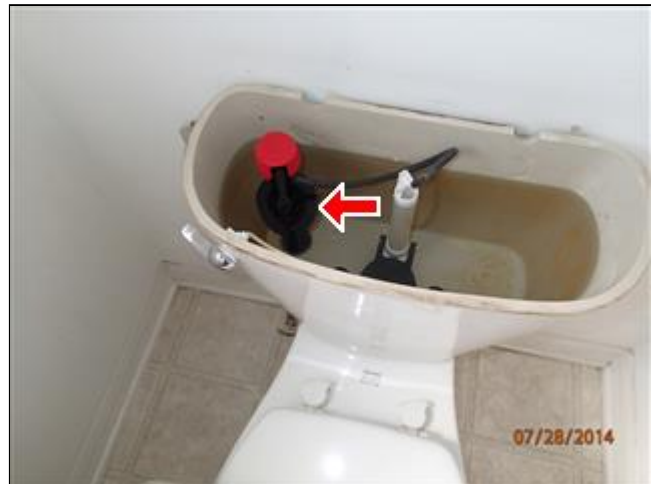
6.1 The kitchen spray wand and faucet had very low water volume/pressure, recommend further evaluation and repairs.

Both toilets were loose on the floor and show evidence of prior leakage, repairs needed.

The toilet in the master bathroom has a defective fill valve, some times it did not allow water to flow, repair or replace the valve as needed.

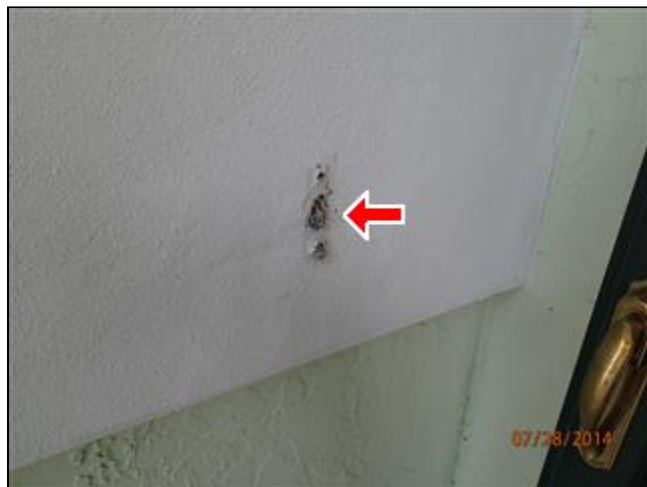
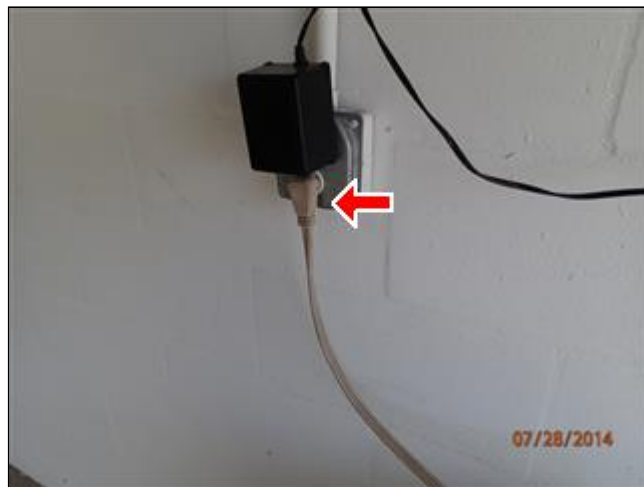
**7.3** The door bell was missing, replace door bell.

The sprinkler pump was plugged into an outlet in the garage and causing the GFCI outlet to trip. The pump should be hard wired and on its own circuit breaker, corrections needed.

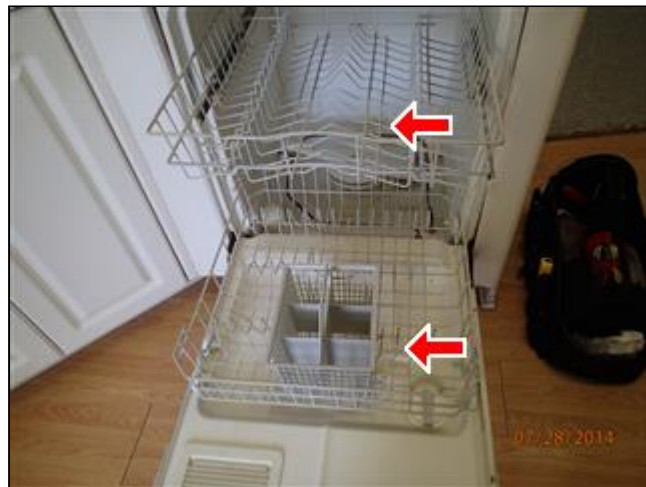
10.0 Picture 1

10.0 The dishwasher racks show evidence of rust damage, recommend replacing racks.

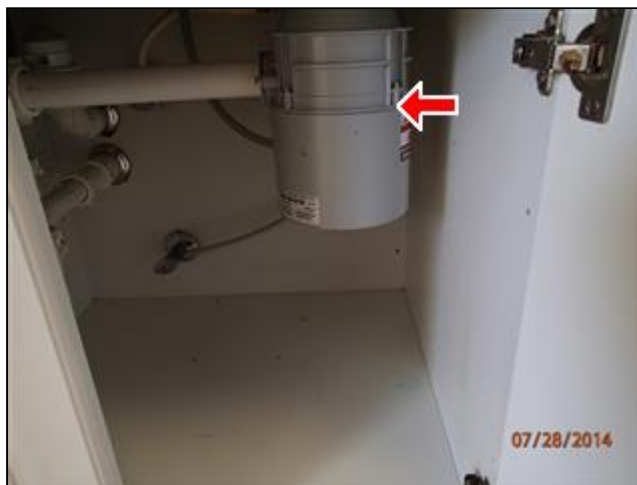
10.4 Picture 1

**10.4** The garbage disposal did not operate, repair or replace as needed.

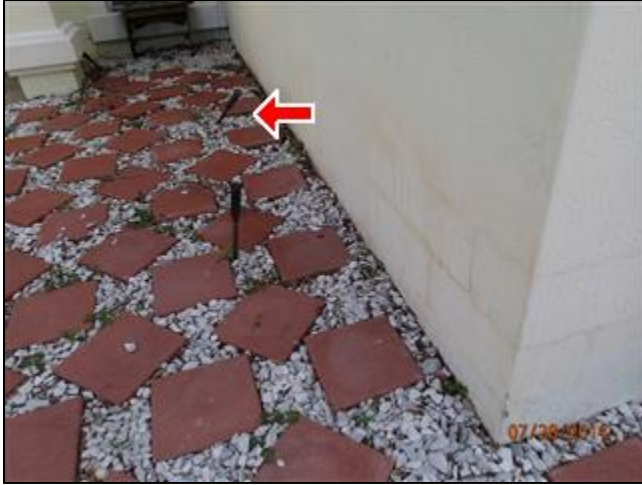
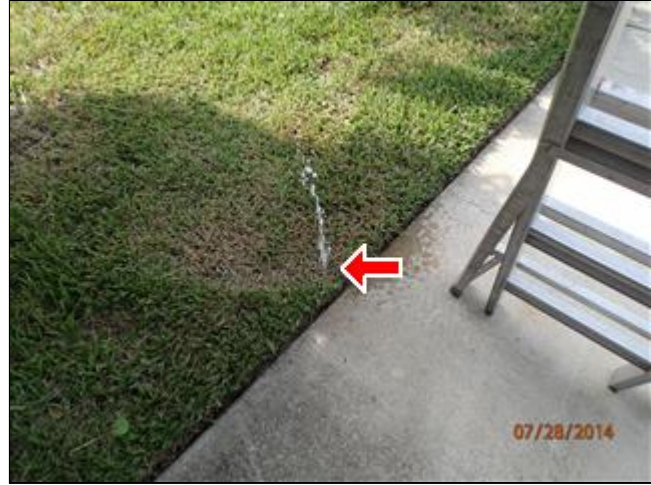
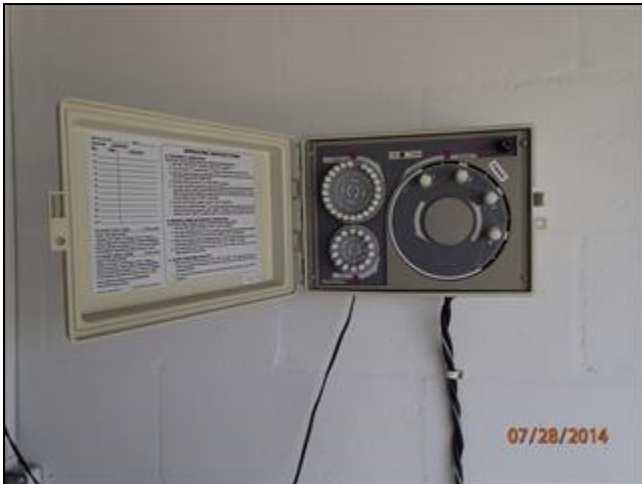
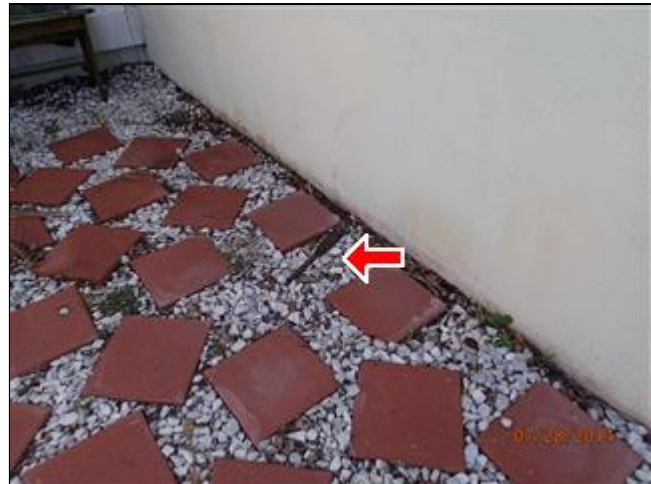
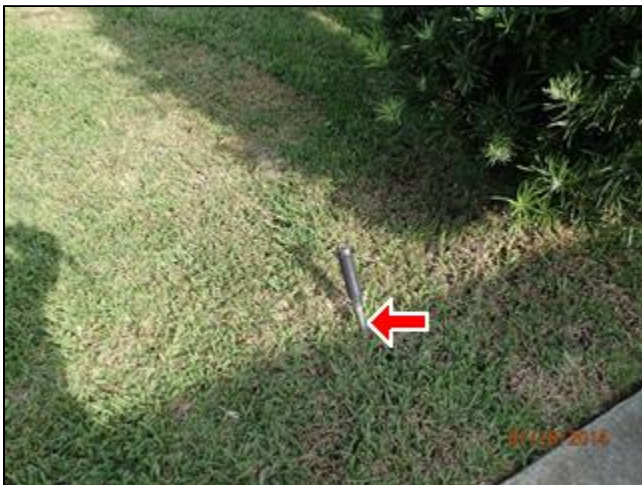
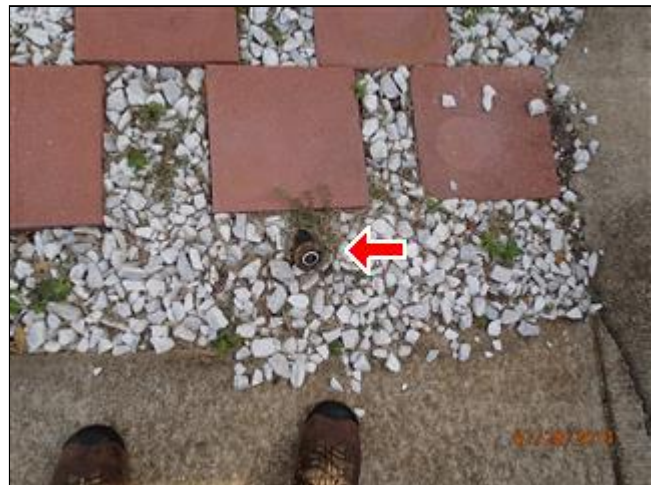
**12.0** The sprinkler system did not operate properly, two zones did not come on, several sprinkler heads were either damaged, loose and not spraying in the proper direction, repairs needed.
